# Roof Inspection Report

Report #13298 | 27/10/26

| <b>Re</b> | Quote Request – 20/10/26; Roof Inspection Report – Kitchen Ceiling Leak |
| <b>For</b> | Blacktown NSW (street address removed) |

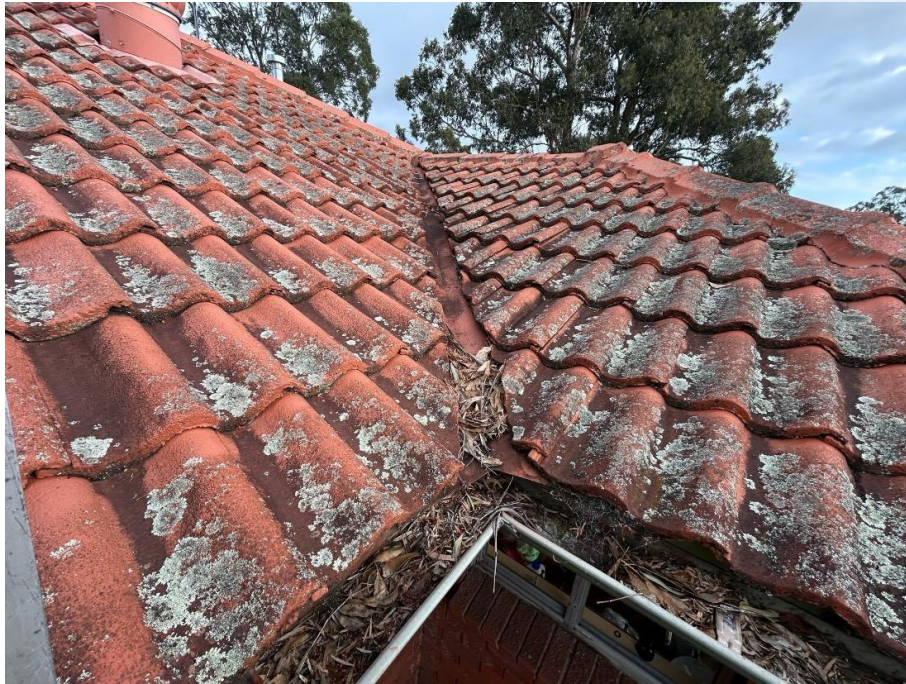
The leak to the kitchen ceiling was traced to the valley (the metal channel where two roof slopes meet and carry water down to the gutter) above the kitchen. Strips of wool were found lodged along the side of the valley, and material like this holds water and can channel it over the edge of the valley iron and under the tiles. We recommend lifting the tiles along the valley, removing the existing valley iron and installing a new one, then reinstating the tiles. The ridge caps at the top of the valley will be disturbed by the replacement, so these will be rebbed and pointed into position once the new valley iron is in.

*Existing valley iron to be replaced*

| <ul style="list-style-type: none"><li>- Alert residents &amp; set up safety signage</li><li>- Where required fall restraint harness used to comply with WHS</li><li>- Photos taken, sent via email</li><li>- Remove tiles along valley, remove existing valley iron &amp; supply &amp; install new valley iron (orange), reinstate tiles x 5 L/m</li><li>- Rebed &amp; point caps after valley iron replacement x 3</li><li>- Supply &amp; install Presstite x 8 L/m</li></ul> | |

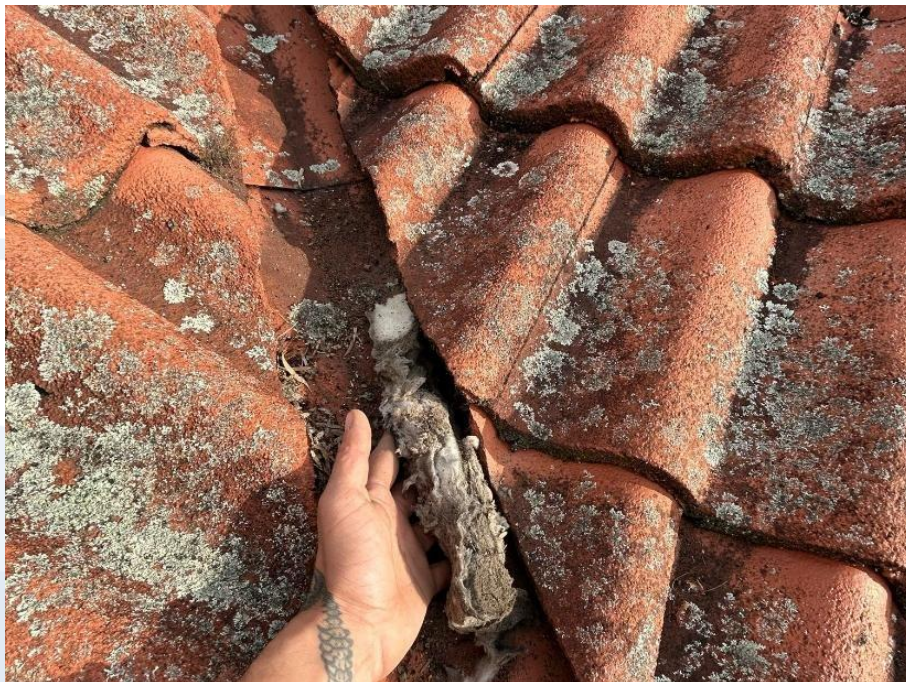
*Strips of wool lodged along the side of the valley*

To further protect the valley, we recommend installing new Presstite (a flexible, self-adhesive sealing strip) to the relevant areas along the valley. This closes the gaps between the tiles and the valley iron, helping to stop wind-driven rain and debris getting in.
